STRUCTURAL REPORT
FOR TATTON BARN, HAMSTREET ROAD,
HAMSTREET, KENT

June 2025
Project No 3674

By Joanne Whiley BEng CEng MStructE

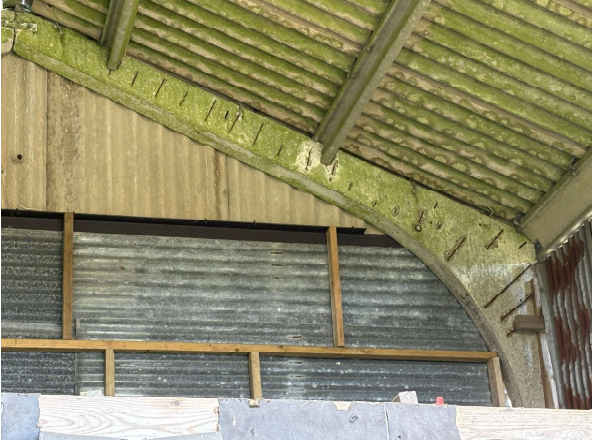
Looking from ground level the concrete purlins, main concrete rafters, and connections appear in reasonable condition. There are some areas where the concrete has spalled, exposing the reinforcement. This often happens on Atcost frames where the concrete cover is small allowing moisture to penetrate. From our inspection we are of the opinion that the exposed reinforcement has not corroded to the extent that the frame's strength

<p>Internal view of concrete frame</p>

will be affected and these areas can be repaired by cleaning and treating the bars and applying a proprietary repair mortar. There are small sections on two of the columns which have been damaged and the reinforcement exposed. In these locations the concrete will need to be cut out locally to allow the repair.

The existing concrete frames will require design checks for the new roof construction. This is best carried out on a comparison of loading basis with the new roof covering selected to be as light as possible. There is some spalling of the concrete to the Atcost frame which can be repaired relatively easily as part of the works. The capacity of the timber members can be calculated and additional members inserted where necessary. The main vertical supporting posts are adequate.

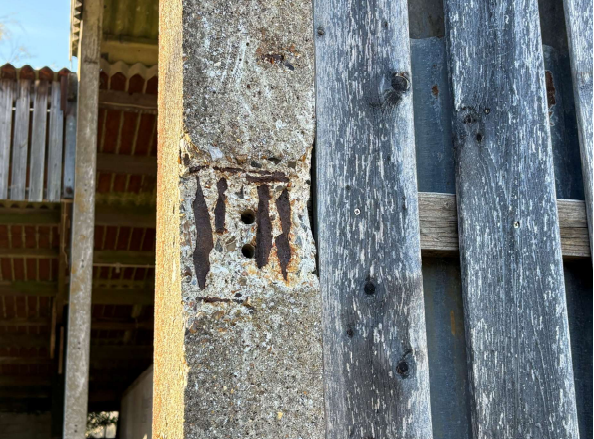
A photograph showing the interior of a barn with a concrete frame. The roof is supported by wooden beams, and there is a brick wall in the background. The floor is concrete, and there is some grass and dirt in the foreground.
<p>Spalling of concrete to frame</p>

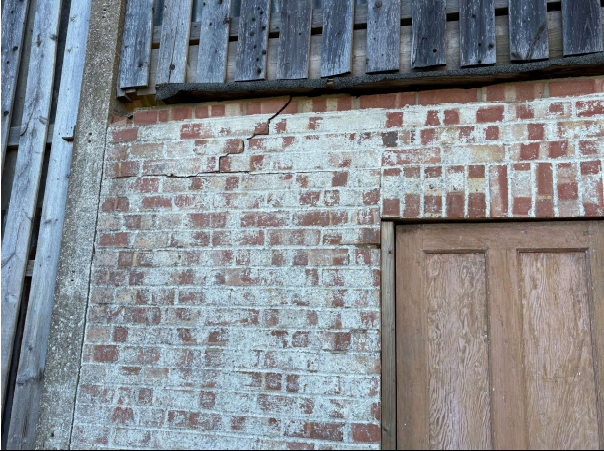
<p>Localised crack to brickwork</p>

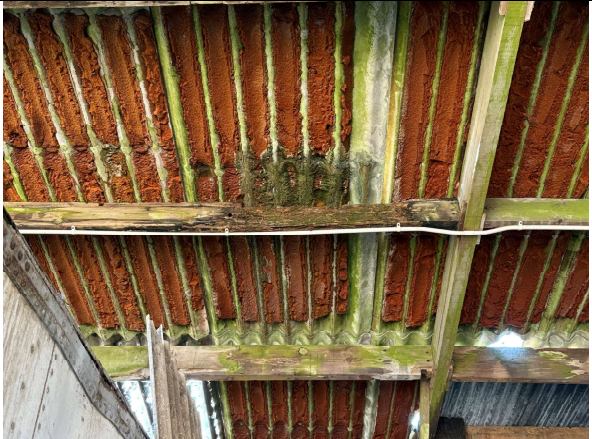
The rear section of the building is approximately 14.5 by 10m on plan and is single storey. The monopitch roof is constructed using corrugated cement sheeting supported on timber purlins and beams which are connected to the concrete frames at the front. Internally and on the perimeter, the roof structure is supported on substantial timber posts. The timber roof members are in reasonable condition although localised members have suffered from decay and some previous repairs are evident. The main posts are in good condition.

<p>Decayed purlin</p>

The timber framed section will require some repairs with some additional roof members inserted between the existing to assist in supporting the new roof covering. The existing timber posts are in good condition and a check calculation shows that they are adequate to support the roof loads.

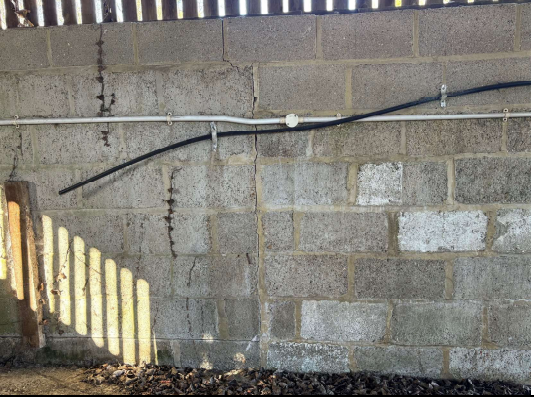
<p>Local crack to block infill wall</p>

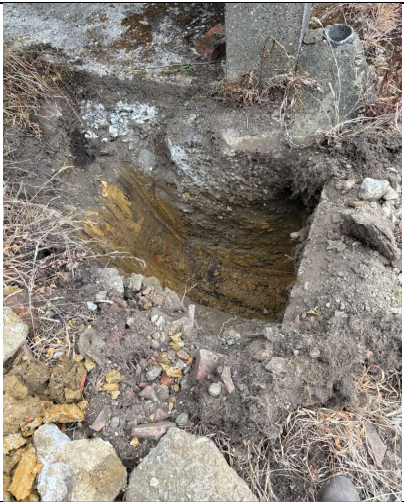
A trial pit was dug adjacent to the front corner column and the foundation was found to be a concrete pad approximately 800mm square and 1 metre deep.

The foundations are concrete pad foundations. Based on a roof loading of 1.1 KN/m² the column load would be approximately 25KN including the frame which would result in a bearing pressure of 39KN/m² based on 800mm square. This pressure is low and, in our opinion, would be acceptable.

A photograph showing a vertical crack in a grey concrete block wall. A black pipe runs horizontally across the wall above the crack. Sunlight filters through a window on the left, casting shadows on the wall.
<p>Trial pit 1 adjacent concrete column</p>

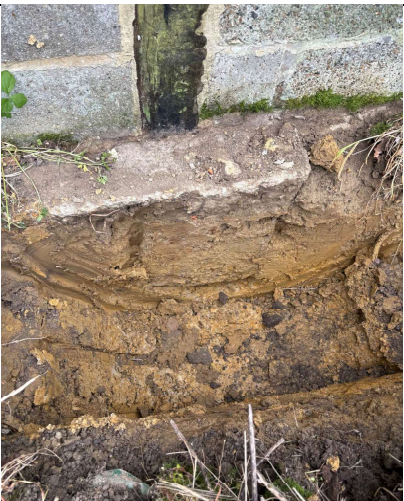
The internal posts bear onto the concrete slab although it looks like there are pad foundations based on the square shaped areas with different concrete. The slab varies in level and there is some cracking. A trial pit was dug to expose the foundation under one of the perimeter posts and the foundation projects from the wall 200mm, is approximately 450mm long and 680mm deep.

A photograph of a trial pit dug in the ground. A concrete column is visible on the right side of the pit. The soil is dark and appears to be a mix of earth and gravel.
<p>Trial pit 2 adjacent timber post</p>
