**Bagshot Cottage,  
Wellhouse Lane,  
Badlesmere,  
Kent  
ME13 0LA**

**Updated Heritage Statement**

**March 2019**

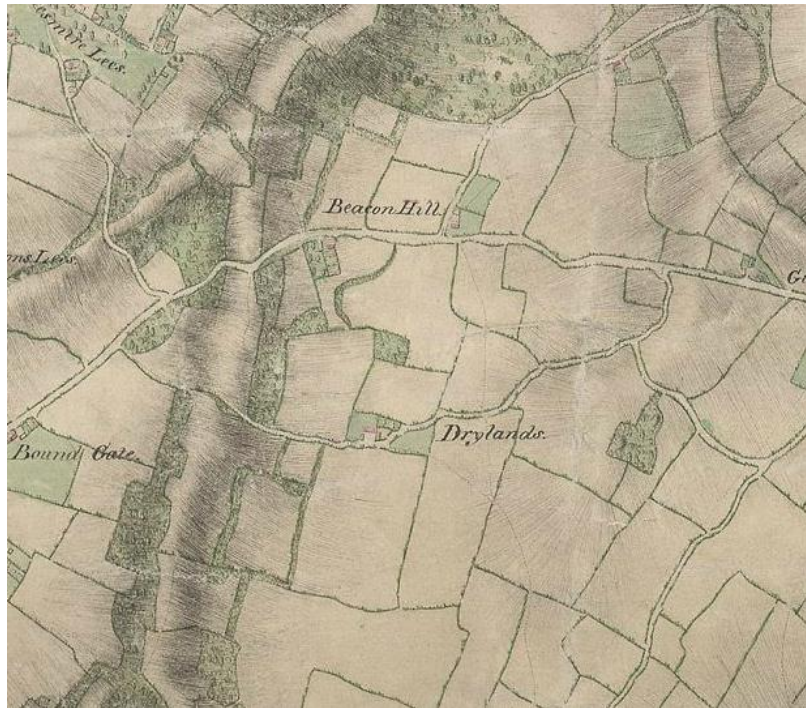
Fig 1: Bagshot Cottage, marked as Beacon Hill on a 1797 map (British Library) <sup>8</sup>

3.14 Again, not untypically, the farmhouse and any land apportioned to the property may have been subsumed into a larger estate thereafter. Archival evidence seems to suggest that the building could have existed as part of Drylands Farm estate, which in the 1750s consisted of 140 acres. The 1797 Andrews, Dury and Herbert map shows Bagshot Cottage named as 'Beacon Hill' and lying to the north of Drylands farm, and it is similarly named on the 1801 Mudge map (see Figs 1 and 2).

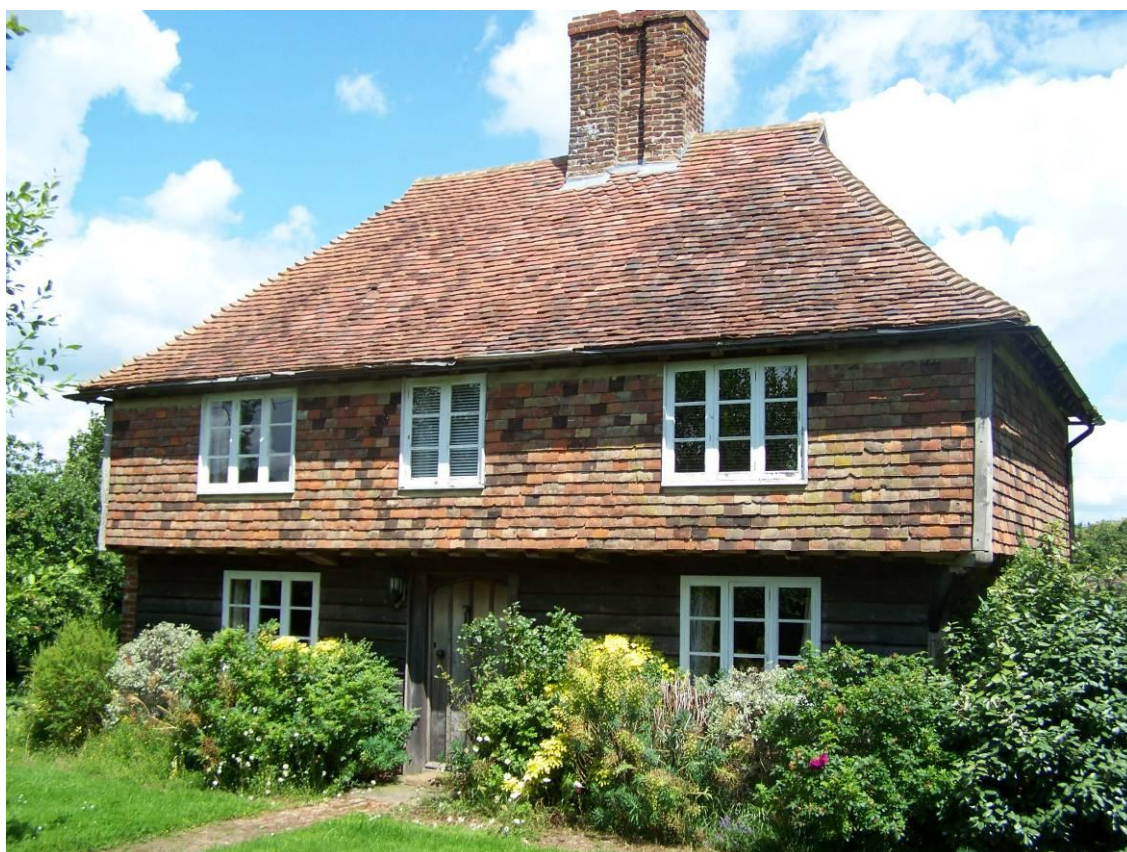
**Figure 13: Bagshot Cottage, Front Elevation**

- 4.1.1 The list description for Bagshot Cottage (**Figure 13**) is succinct. The building is noted to be a sixteenth century house, timber framed and tile hung on first floor, with a plain tile roof. Constructed to two storeys with a continuous jetty supported on dragon posts (**Figure 14**), the whole is surmounted by a hipped roof and central chimney stack. Two wood casements are noted to each floor, as is a central boarded door. The numerous alterations undertaken since the sixteenth century and discussed above are not taken into account and in general, the description is not detailed.

- 4.1.2 It is clear from the building's exterior that it is constructed to two storeys, is timber framed, and tile hung to first floor with a plain tile hipped roof and central chimney stack. As noted however, the described jetty is not continuous whilst the north-west elevation has a brick rather than weather-boarded ground floor elevation. Given the glazed-headed Flemish bond to this elevation, with exposed headers burned so they are vitrified to a black glaze (**Figure 15**), this is likely to date to the early eighteenth century, when such an effect was popular. This represents a still further phase not necessarily identifiable or made clear by documentary or map-based evidence. The soldier-course window arch in this elevation is also likely to be fairly recent (twentieth century) and probably replaces a window arch comprising a simple timber lintel.

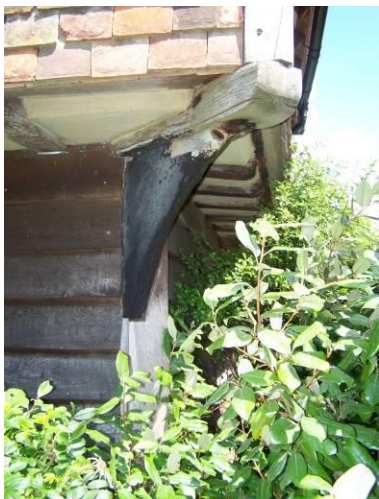
**Figure 14: Dragon Post**      **Figure 15: Glazed-Headed Flemish Bond**

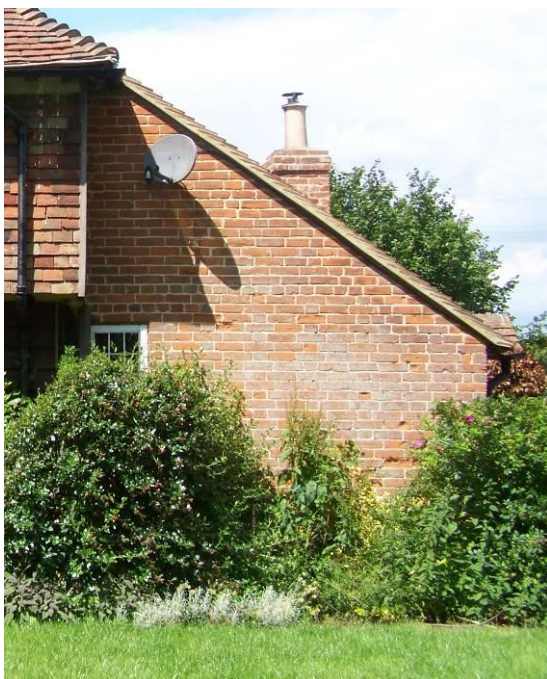
- 4.1.3 Similarly, the one storey lean-to to the rear is also considered to date to the eighteenth century, given its hand-made brick and Flemish bond (**Figure 16**). It is difficult to establish whether or not this is slightly earlier, later or contemporary to the principal building's north-west elevation, which may have a more elaborate bond due to its position on the main house. Constructed in an English bond, the north-west elevation of the one storey lean-to however (**Figure 17**), was rebuilt in the nineteenth century of a darker, purple/brown brick and has a door set into this with a segmental or cambered arch, again indicating a later than eighteenth century provenance.

**Figure 16: Flemish Bond (to jetty level)**      **Figure 17: English Bond, Segmental Arch**

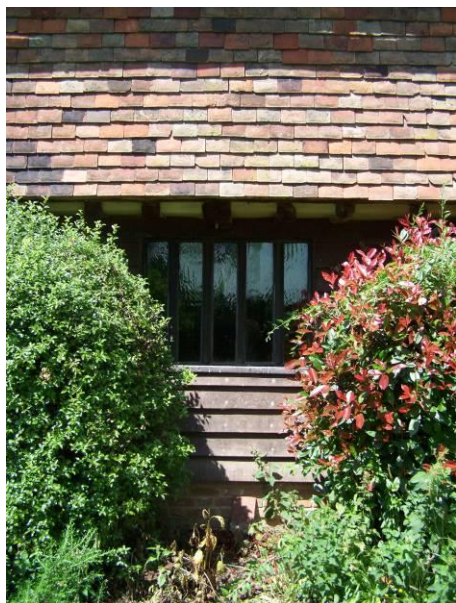
**Figure 18: Timber Mullioned Window**

- 4.1.4 To the south-east elevation is a timber mullioned window (**Figure 18**), which, although shown by the 2004 as-existing drawings, is also not mentioned by the list description. Individual mullions would originally have been of diamond profile, but are now adapted and/or thickened to accommodate glass lights. In accordance with the 2004 'proposed' drawings, the two casements noted by the list description have now been added to by a third, central casement (**Figure 19**). In the north-east elevation, to

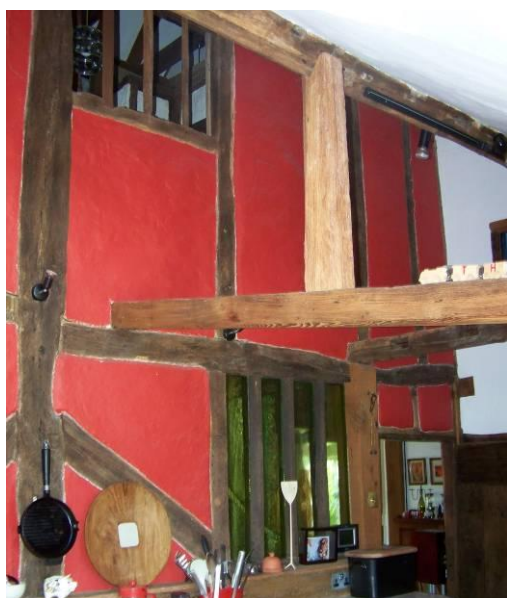
**Figure 20: Former Exterior Elevation**

- 4.1.5 Coming to the structure's interior, the kitchen is most revealing concerning the long evolution of the building. Here can be seen the original north-east elevation comprising timber-framing with wattle and daub panels. A number of further timber mullioned windows illustrate its former role as an exterior elevation (**Figure 20**). The south-east elevation can be more plainly seen to be eighteenth century given its internal brickwork and window's timber lintel, whilst the lean-to extension's roof structure can also be seen to comprise a variety of re-used timbers from a number of periods. An internal (now) dividing wall of timber framing at the north end of the kitchen indicates a still earlier extension (sixteenth/seventeenth century), now subsumed into the eighteenth century addition (**Figure 21**).

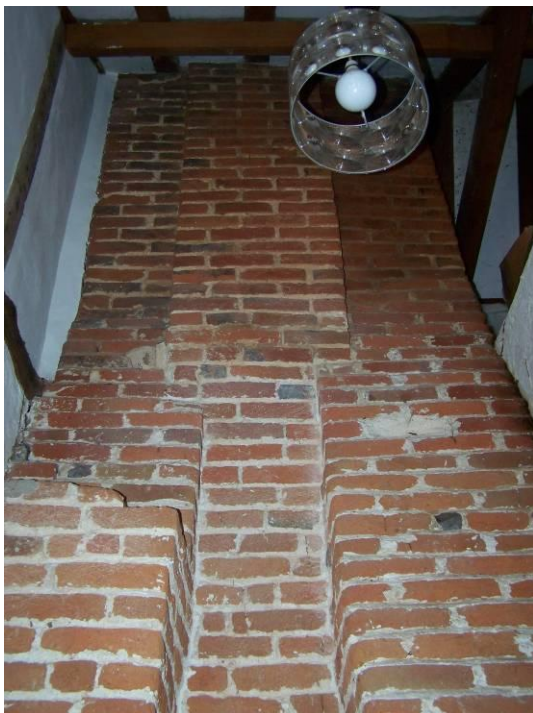
Figure 22: Chimney Stack, Stairwell

- 4.1.6 As indicated by the list description, the chimney is a principal feature (**Figure 22**), perhaps more so in terms of the interior, the spaces being arranged around this central, consistently prominent structure, the stair turning around this on its north-east side (**Figure 23**). As such, fireplaces are a similarly consistent feature or focus in each room, although given the vernacular nature of the property these are of a variety of characters according to their locations (**Figures 24 & 25**). Whilst large, that to the room currently used as a dining room is spanned by a simple bressumer (a model repeated upstairs), whilst that to the room currently used as a lounge is more elaborate, with a Tudor arch originally in moulded brick, although this is now stuccoed or rendered over.

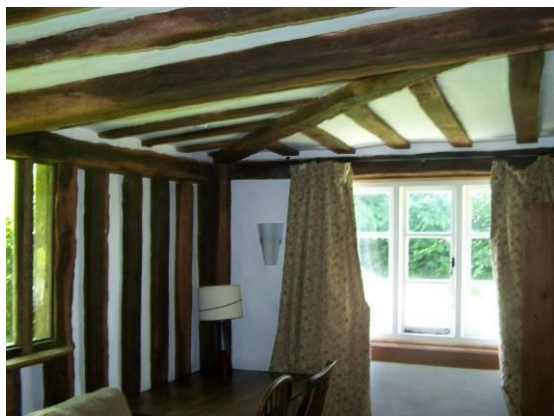
- 4.1.7 As discussed above in Section 3, timber framed elements of the structure have been extensively replaced, this being most clear to the interior. Whilst the lounge exhibits the original dragon post configuration (**Figure 26**), much of the dining room framing can be seen to have been entirely replaced (**Figure 27**). This replacement is similarly extensive throughout the roof structure at upper levels where a variety of old and (mostly) new timbers comprise the frame (**Figures 28 & 29**). This mix of fabric most clearly represents the extent and nature of reinstatement required as part of the 2004

**Figure 26: Dragon Post Configuration**   **Figure 27: Replaced Framing**

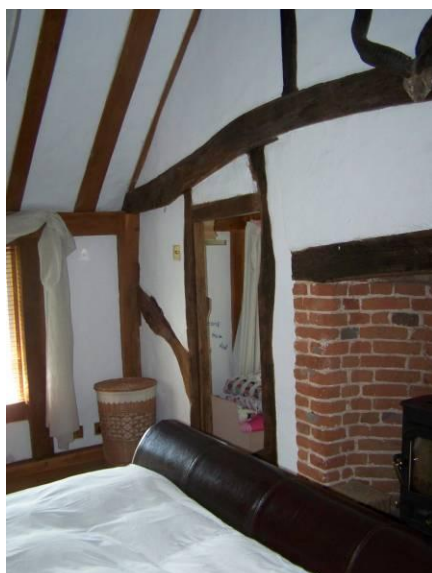
**Figure 28: Old & New Timbers**   **Figure 29: New Roof Structure**
