**Rolvenden Primary School, Hastings Road,  
Rolvenden, Kent.**

**Preliminary Ecological Appraisal**

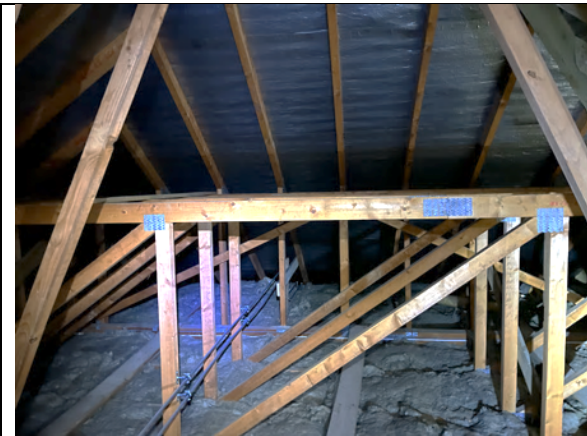
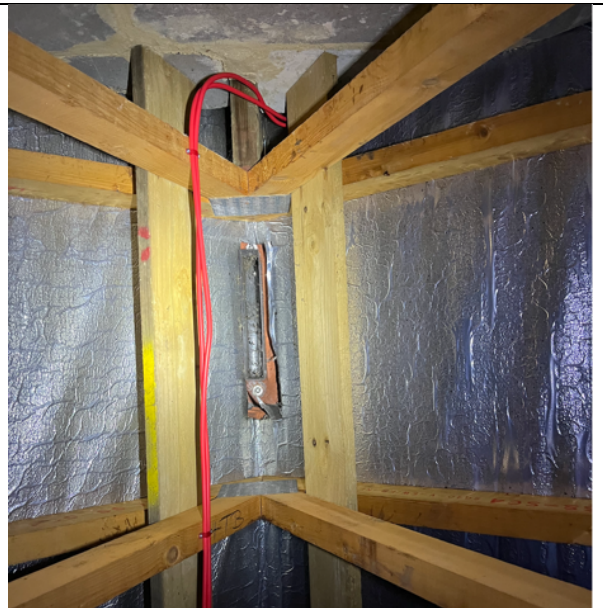
Photo 1. Main roof void with machine-cut timber framework, sealed foil-backed insulated roof lining and rock-wall floor insulation

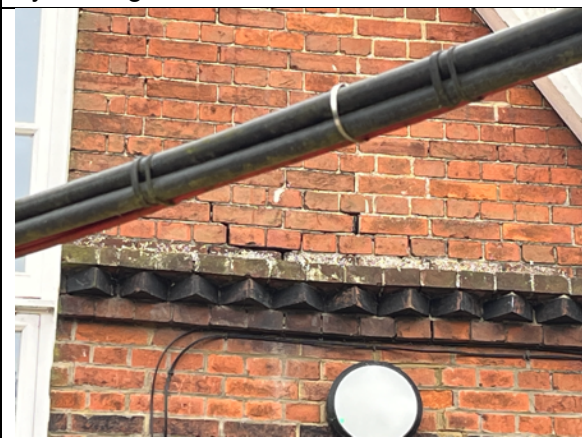
Photo 7. Brickwork cracks on north-east elevation of main building, found on close-inspection to be too shallow (<3cm) to support roosting bats

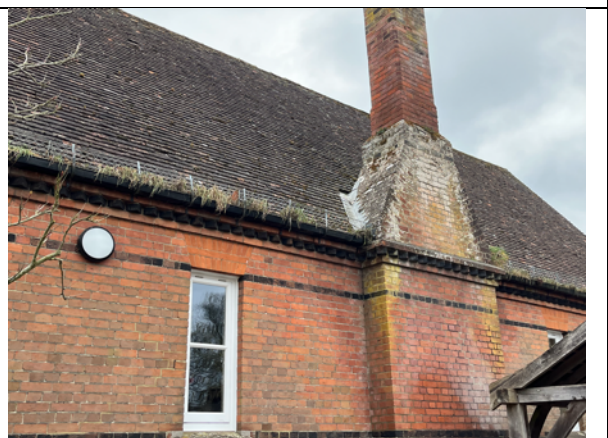
Photo 8. North elevation of main building, with a few gaps under tiles, but no gaps in brickwork, no soffits, and no access to internal void at eaves level

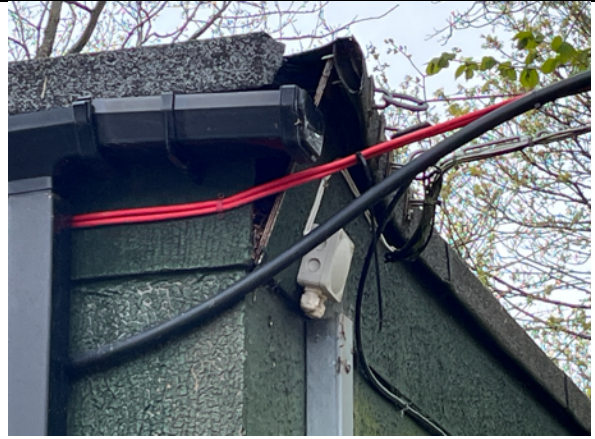
Photo 10. Flat felt roof to portacabins, damaged on one corner, forming a limited cavity. This had minimal bat roost potential, but some bird nesting potential. Direct torchlight inspection found no evidence of bird nesting or bat presence at the time of survey

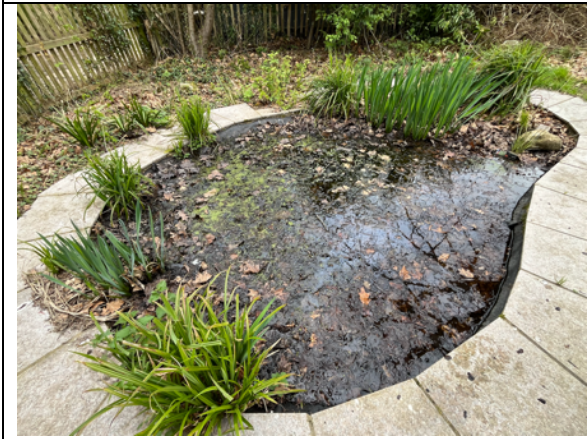
Photo 11. On-site ornamental pond, choked with leaf debris and heavily shaded

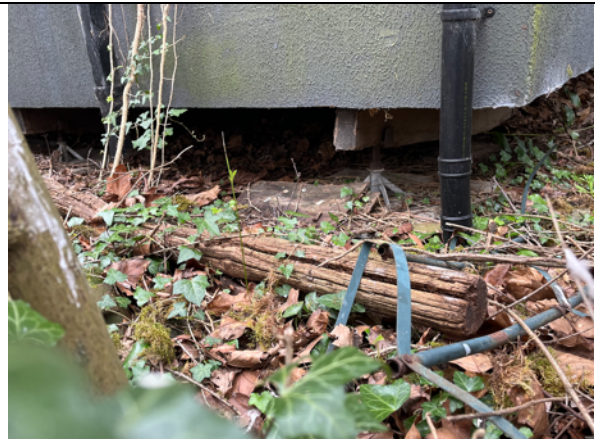
Photo 12. Debris surrounding and under portacabins near to pond, to be checked and cleared under ECoW supervision prior to portacabin demolition
