STRUCTURAL REPORT
FOR TATTON BARN, HAMSTREET ROAD,
HAMSTREET, KENT

June 2025
Project No 3674

By Joanne Whiley BEng CEng MStructE

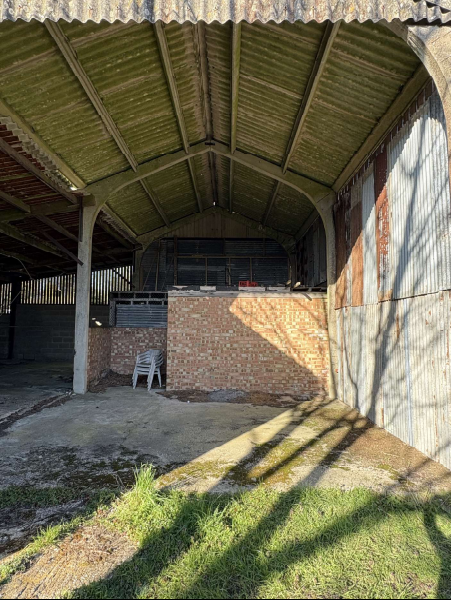
<p>Internal view of concrete frame</p>

Looking from ground level the concrete purlins, main concrete rafters, and connections appear in reasonable condition. There are some areas where the concrete has spalled, exposing the reinforcement. This often happens on Atcost frames where the concrete cover is small allowing moisture to penetrate. From our inspection we are of the opinion that the exposed reinforcement has not corroded to the extent that the frame's strength

will be affected and these areas can be repaired by cleaning and treating the bars and applying a proprietary repair mortar. There are small sections on two of the columns which have been damaged and the reinforcement exposed. In these locations the concrete will need to be cut out locally to allow the repair.

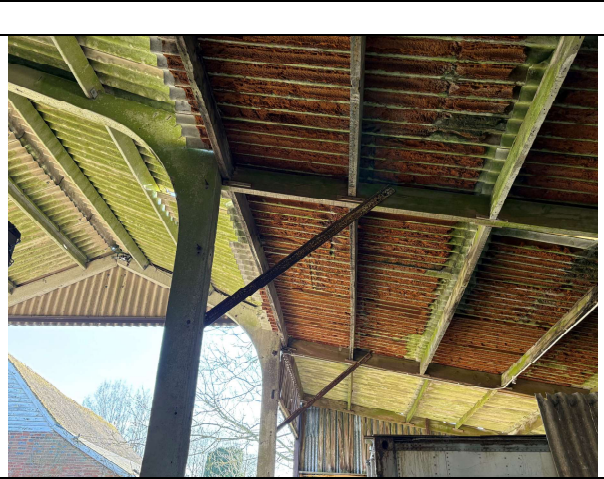
<p>Connection timber roof to concrete frame</p>

The rear section of the building is approximately 14.5 by 10m on plan and is single storey. The monopitch roof is constructed using corrugated cement sheeting supported on timber purlins and beams which are connected to the concrete frames at the front. Internally and on the perimeter, the roof structure is supported on substantial timber posts. The timber roof members are in reasonable condition although localised members have suffered from decay and some previous repairs are evident. The main posts are in good condition.
